How Mitigation Techniques Affect Reliability Results for BGAs

Greg Caswell and Melissa Keener

DfR Solutions

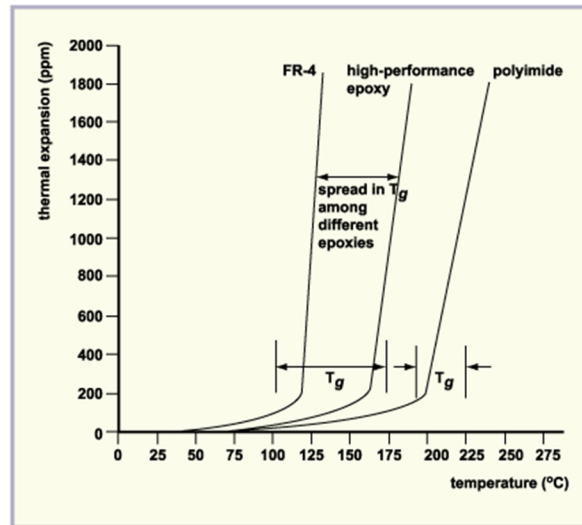
Figure 1: Graph of Glass Transition Behavior of board materials from www.mtarr.co.uk/courses/topics/0140_pl/index.html

With the enforcement of RoHS requirements, there has been some concern about the reliability of lead-free solders. The reliability of tin lead solder is well known as a robust solder and the failure rate is well characterized, whereas SAC solders are known to be less robust which is a problem for some high reliability applications. One solution is to mitigate the solder joints with a staking material to strengthen the joint, but the problem is choosing the correct material for the application. Several material properties, such as glass transition temperature (T_g) and coefficient of thermal expansion (CTE), need to be properly chosen. Improperly chosen mitigation materials will cause premature failures instead of extending the time to failure. If the expected operating temperature of the device is too close to the T_g , the CTE will drastically change which can cause solder joint failures as shown in Figure 1.

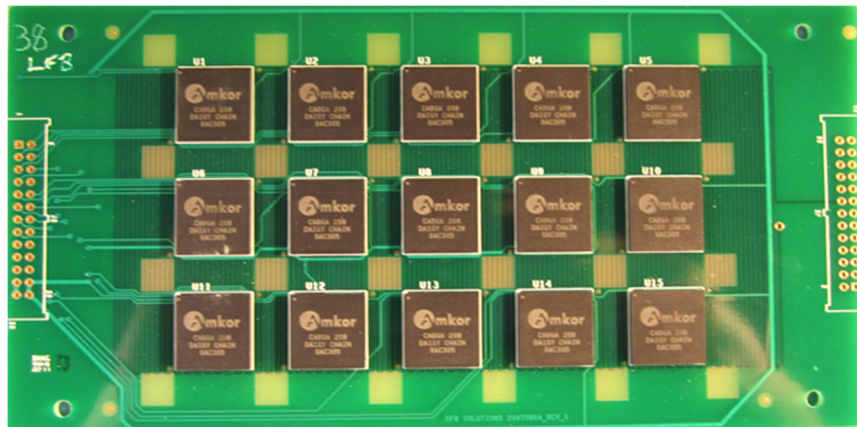
Figure 2: Test PCB

This study chose to focus on one component type: the Ball Grid Array (BGA). The BGAs that were chosen were 15mm by 15mm packages with 208 balls. The balls were 0.5mm in diameter and had a pitch of 0.8mm. The balls were attached to the BGA along the perimeter 4 rows deep. The BGAs were purchased with tin lead (SnPb) balls and reballed to attach the SAC305 and SN100C solder balls. The reballing process does not have an effect on the reliability of the component, it could increase the strength of the solder ball interconnect by at most 10%. [1] These BGAs were attached to 4 layer FR4 printed circuit boards (PCBs) as seen in Figure 2.

The PCBs arranged the components into 4 rows and 5 columns. The placement of the component was determined by first vibration mode as calculated through finite element analysis and shown in Figure 3. The figure shows that the center column and the column on either side are in the highest strain area. The two outside columns are in a lower strain area. This was done so that multiple strain levels could be investigated on one test PCB.

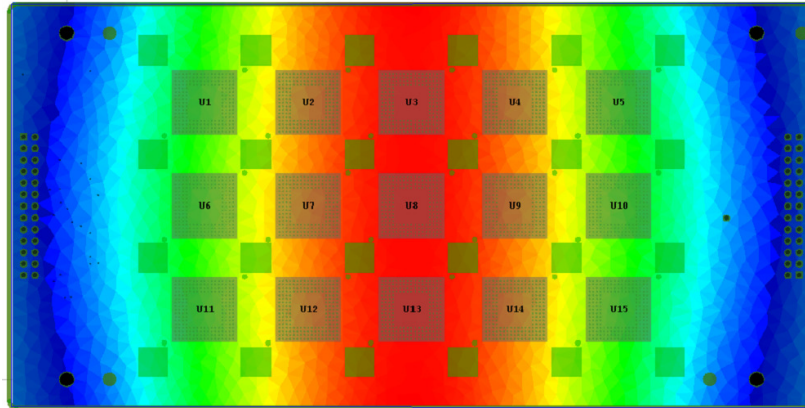
Figure 3: Finite Element Analysis of Test PCB showing natural frequency of the board
